Fawn Lake Preservation Study

PROJECT UPDATE
December 3, 2014

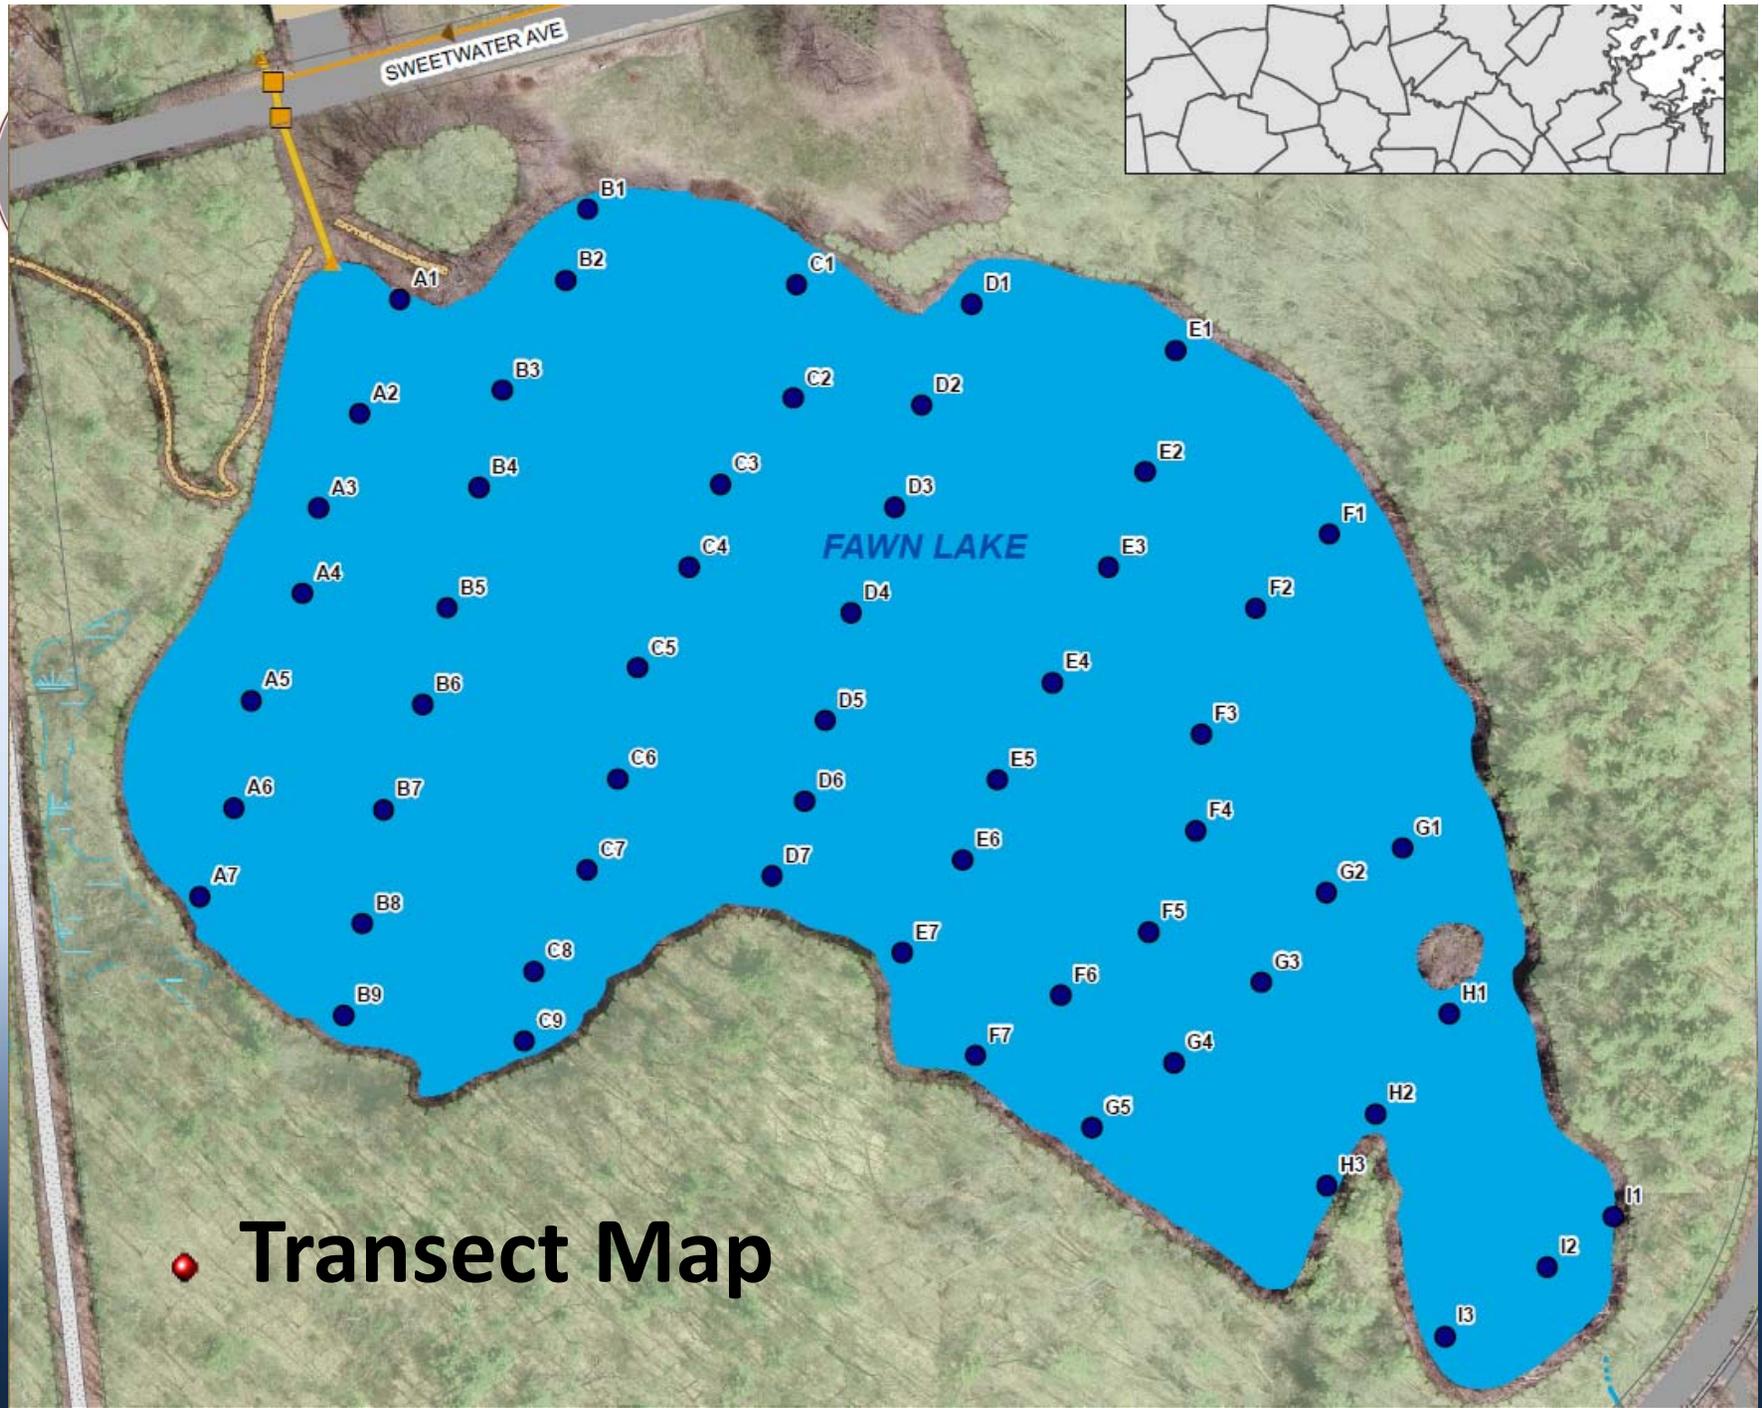
● **Transect Map**

- 9 Transects
 - 57 monitoring points
 - GPS located
- Monitoring Points
 - Sediment and Water Depth Measurements
 - Plant Survey
 - Composite of random locations for two sediment samples

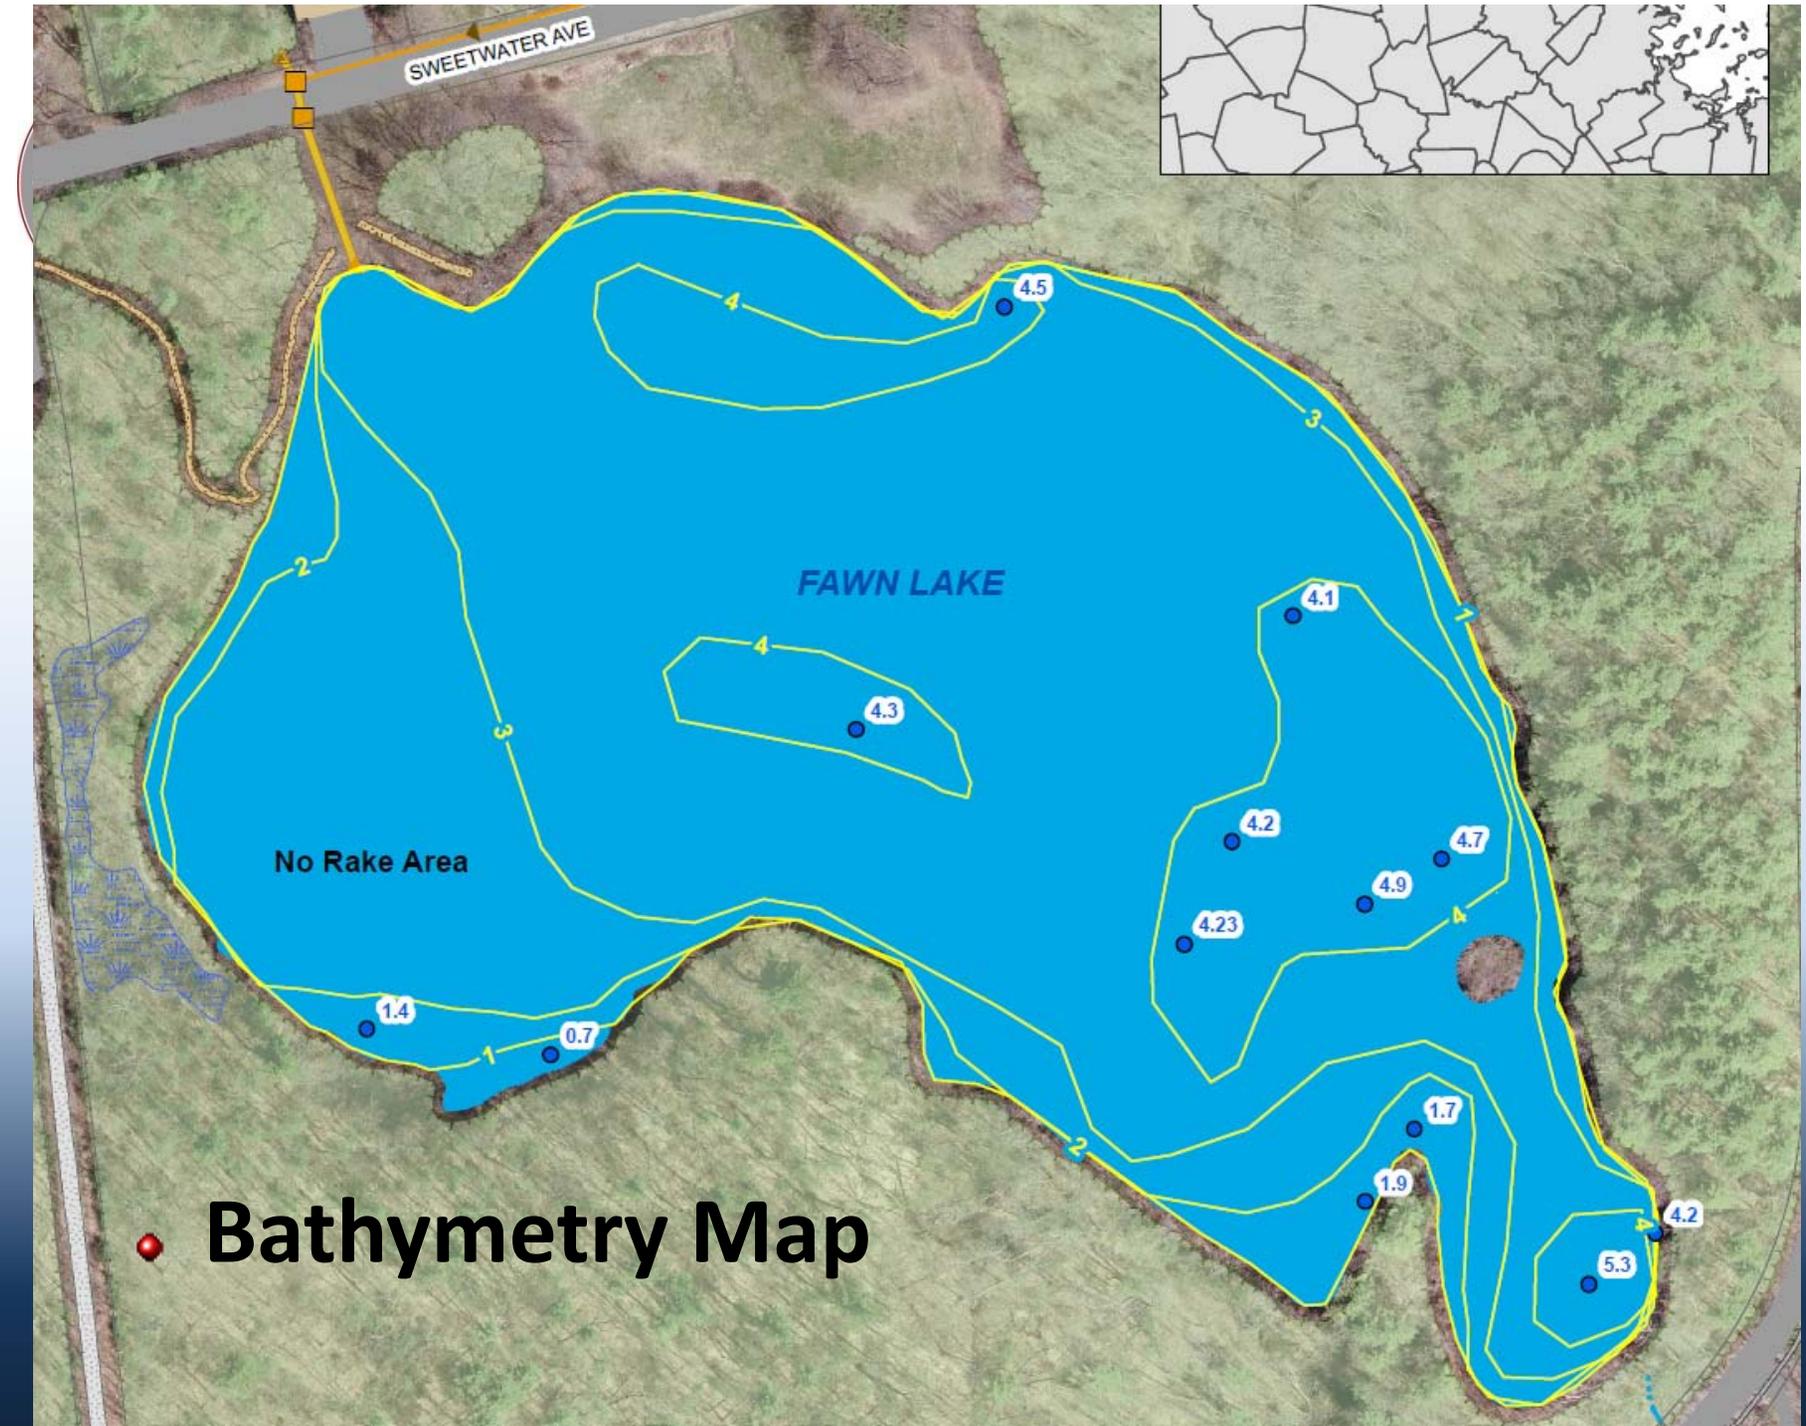
Lake Bathymetry

- Measures Depth of Water Throughout Lake
 - Place Secchi disk on bottom of lake and record the depth from the surface
 - Displayed visually as a contour map of the lake
- Results
 - Depth ranges from 0.7 to 5.3 feet
 - Deepest portions are near the outlet
 - Average depth is 3.3 feet
 - Estimated total volume is 10.2 million gallons

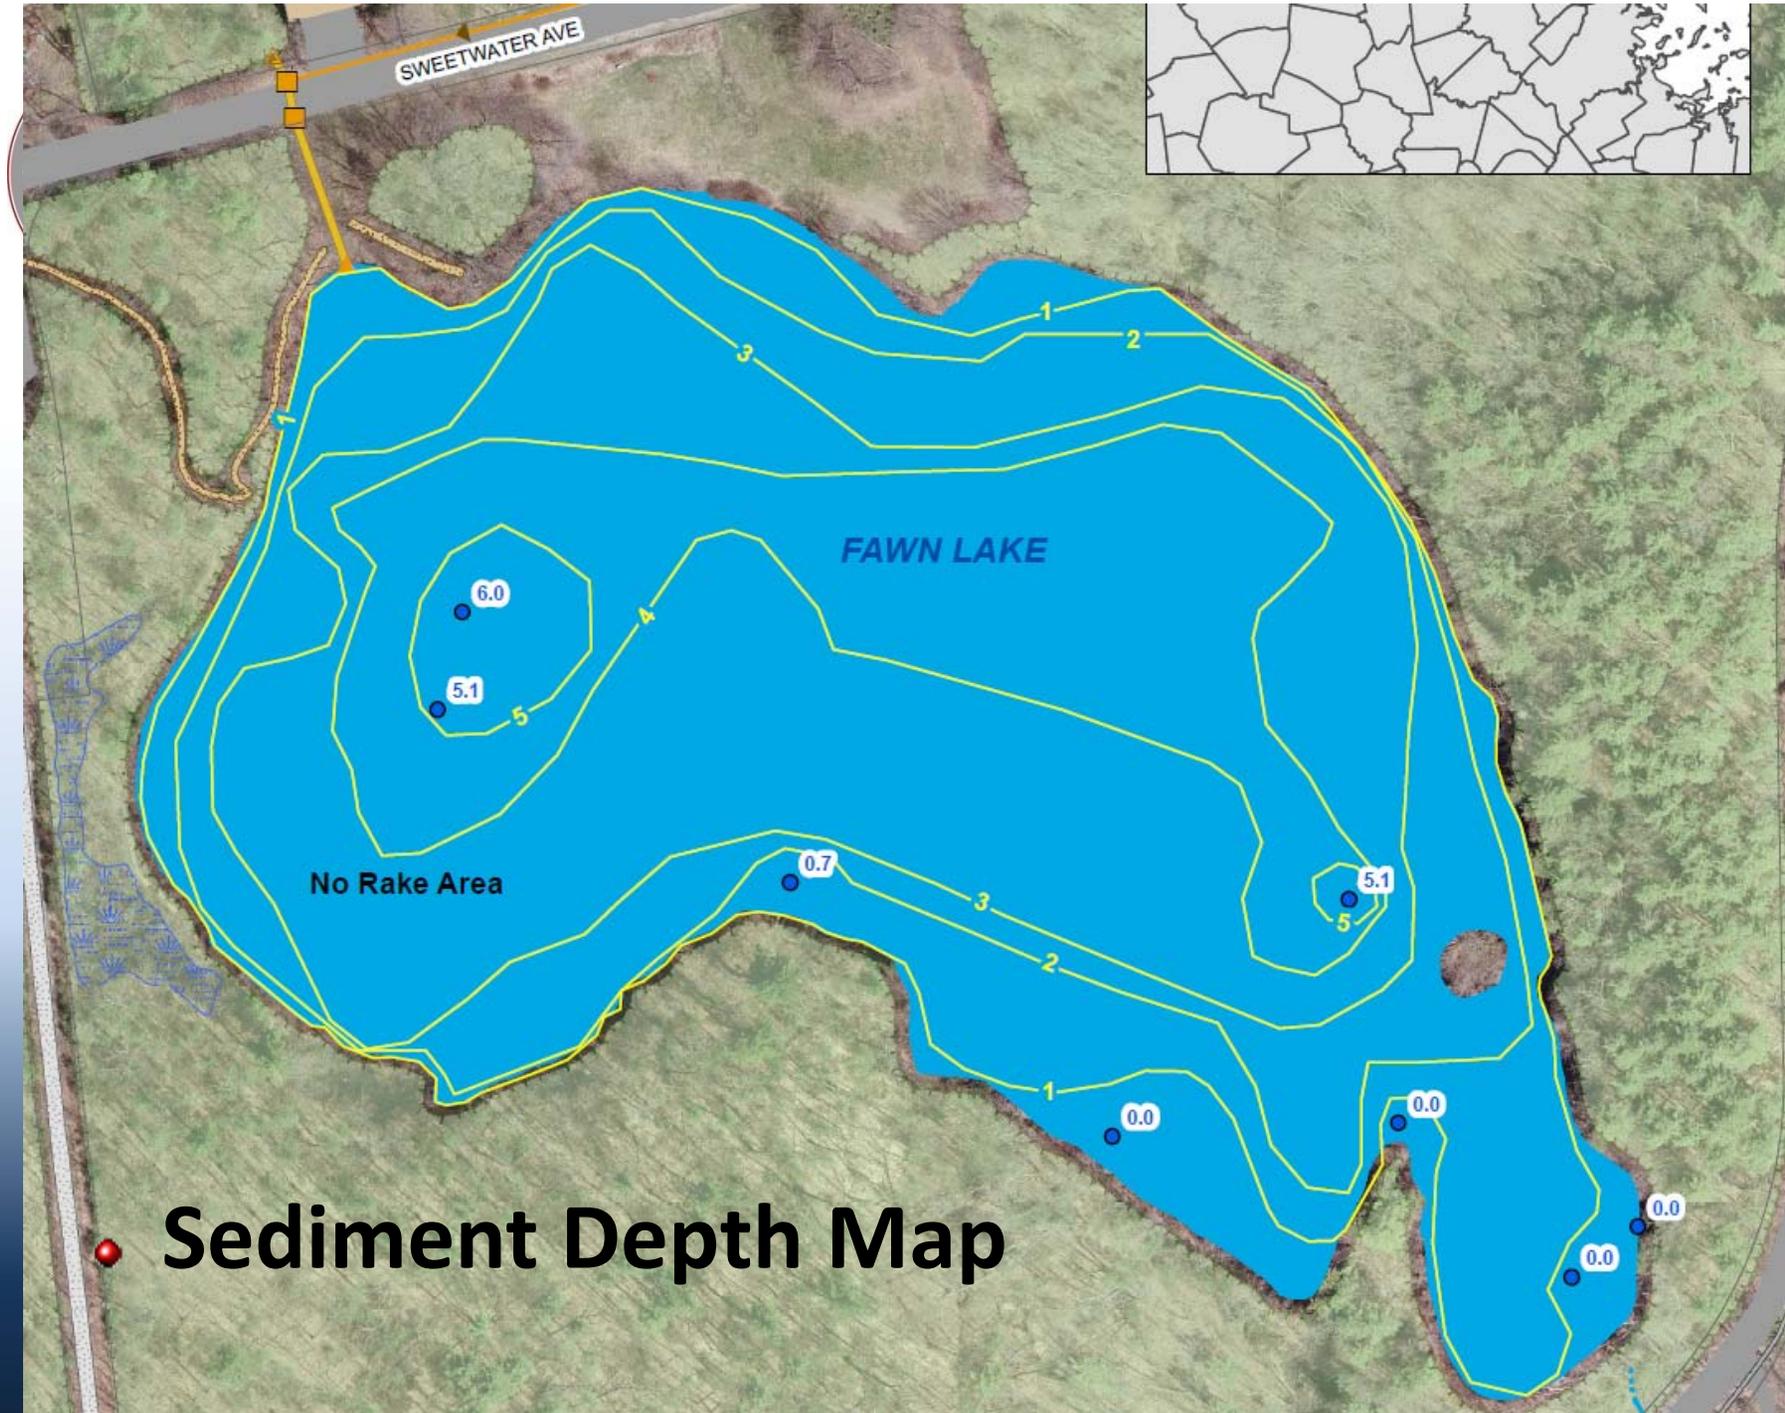
● Sediment Depth Map

- Measures Thickness of Sediment Throughout Lake
 - Place Secchi disk on bottom of lake and record the depth from the surface
 - Push calibrated bar into soft sediment and record total depth
 - Sediment depth is the difference between the two
- Results
 - Sediment depth ranges from 0 to 6 feet
 - Deepest portions: NE of no rake zone, NW of island
 - Average depth is 2.9 feet

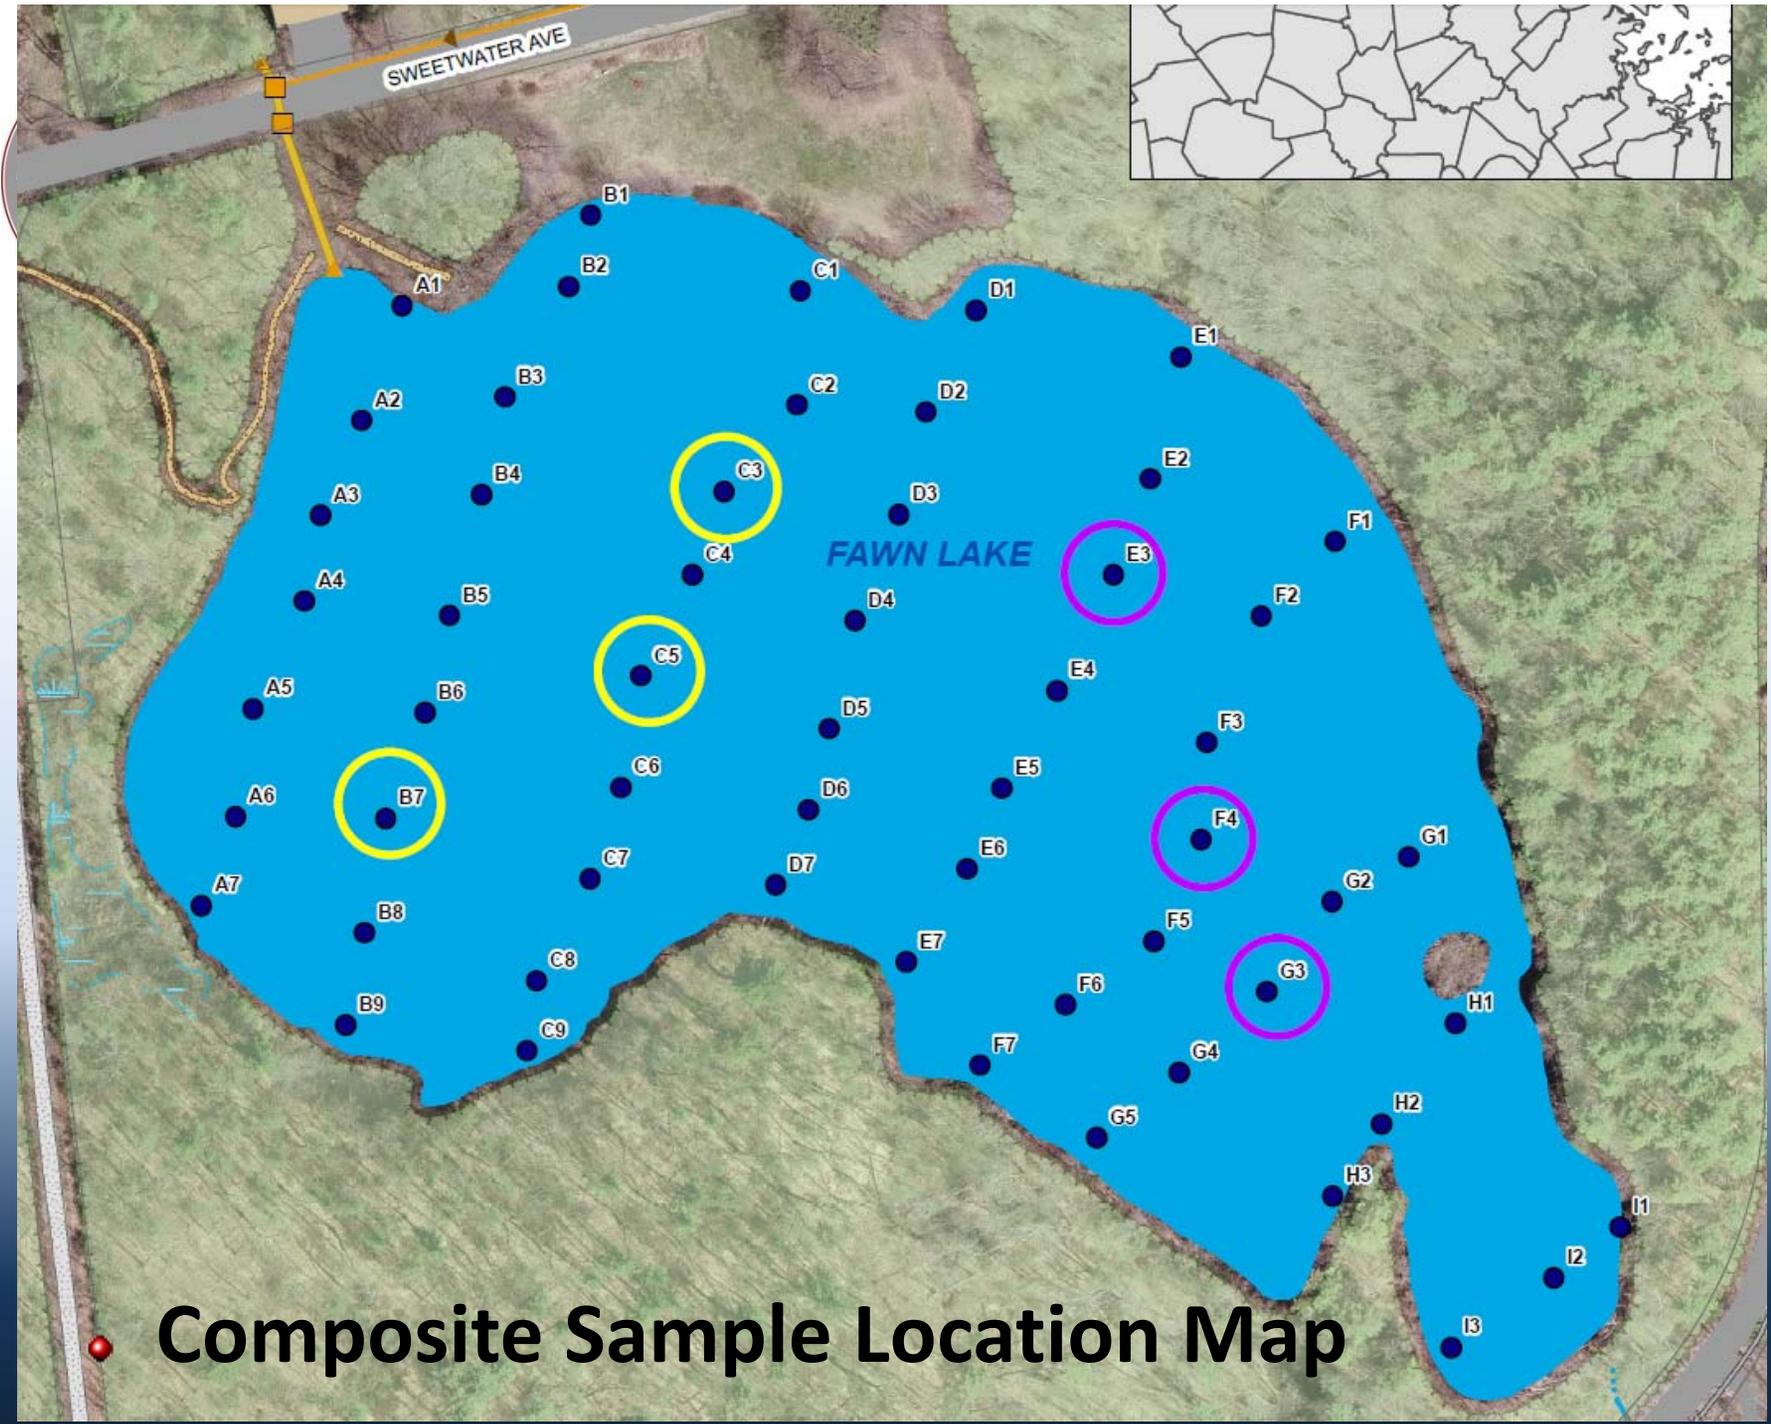
● Composite Sample Location Map

- Collected two composite samples of sediment
 - “West Composite” – 3 sites combined for 1 sample
 - “East Composite” – 3 sites combined for 1 sample
- Both samples were analyzed for:
 - Water Content
 - Metals
 - TPH (Total Petroleum Hydrocarbons)
 - EPH (Extractable Petroleum Hydrocarbons)
 - PAHs (Polynuclear Aromatic Hydrocarbons)
 - VOCs (Volatile Organic Compounds)
 - Sieve Analysis
 - Total Volatile Solids
 - PCBs (Polychlorinated Biphenyls)
