Environmental Compliance Due Diligence Activities Report

U.S. Coast Guard Bedford, Massachusetts Housing Units

1, 2, 3, 4 and 6 Lewis Road
1, 2, 3, 4, 5 and 6 Michelson Lane
33, 35, 37 and 39 Pine Hill Road
Bedford, Massachusetts, 01730
Contract No. GS-00P-14-CY-A-0002/Award No. GS-P-00-14-CY-5026
July 2015

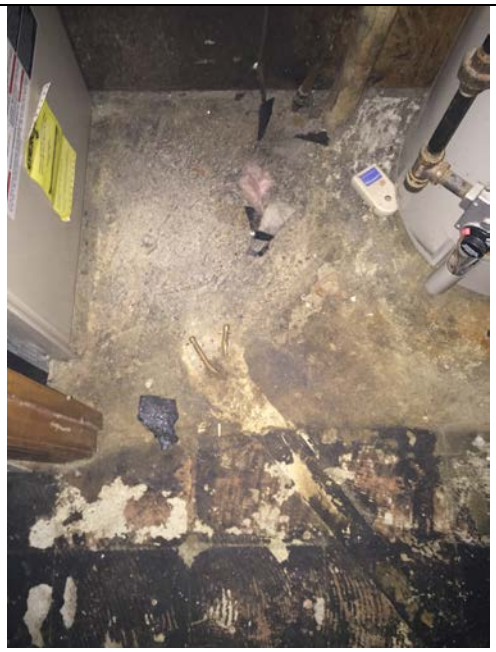
Photo: 4 **Description:** Typical view of the furnace located in the utility closet of each unit.

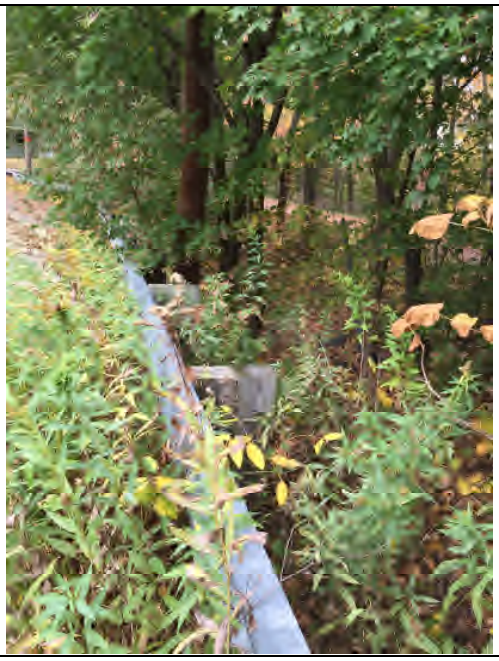
Photo: 4 **Description:** View of a wooded area and trail located to the east of the Site. No wetland were observed in association with the Site.
