Fawn Lake Preservation Study

PROJECT UPDATE
December 3, 2014

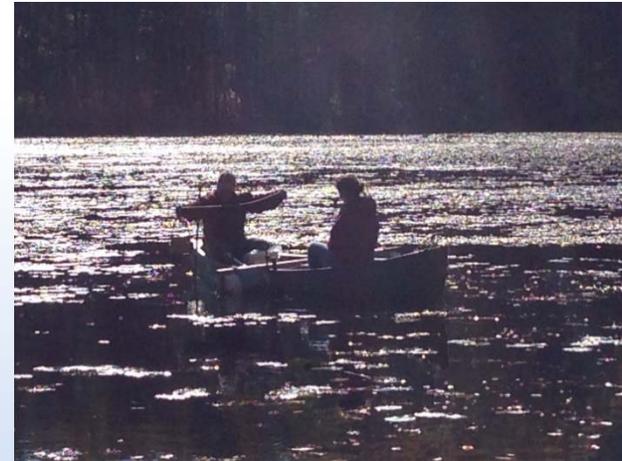
- 9 Transects
 - 57 monitoring points
 - GPS located
- Monitoring Points
 - Sediment and Water Depth Measurements
 - Plant Survey
 - Composite of random locations for two sediment samples
